MTL TR 90-32

# STATIC FATIGUE BEHAVIOR OF STRUCTURAL CERAMICS IN A CORROSIVE ENVIRONMENT

U.S. ARMY MATERIALS TECHNOLOGY LABORATORY  
CERAMICS RESEARCH BRANCH

June 1990

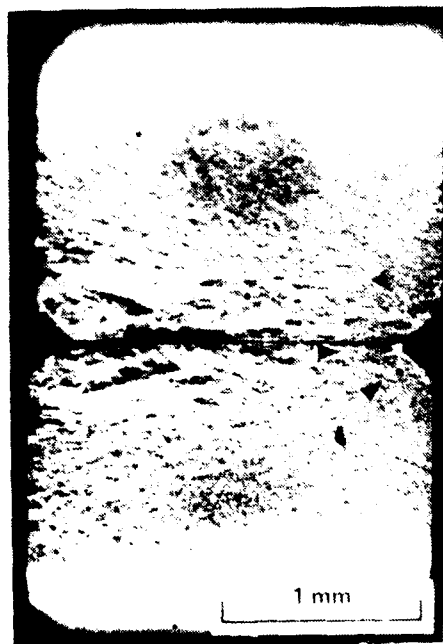
Figure 8. Optical photograph of NC-132 which failed after  $\approx 56$  hours under 450 MPa stress showing the slow crack growth (SCG) region.

At stresses of 500 MPa or greater, optical fractography showed what appears to be a fast fracture-type failure (see Figure 7). Scanning electron microscopy (SEM) fractography revealed that machining damage was the cause of failure. Specimens which were subjected to a 450 MPa stress began to show evidence of slow crack growth (SCG); this was especially obvious in the specimen which failed after  $\approx 56$  hours (see Figure 8). The other specimens which failed at 15 and 20 hours, respectively, showed signs which may be interpreted as SCG, but more in-depth fractography is needed to determine if SCG is present. Specimens which survived 500+ hours under a 400 MPa applied stress without failure showed no signs of creep.

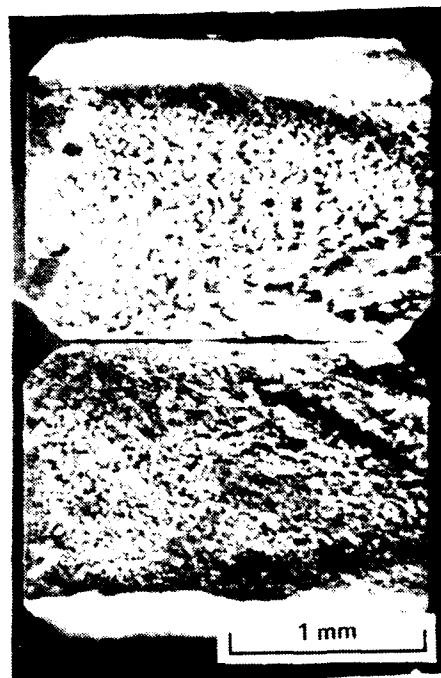
Figure 10. Optical photograph showing that the glassy phase and/or corrosion product flowed over the fracture surface after failure in a stress rupture test.

The addition of 10 to 20 mg/cm<sup>2</sup> of Na<sub>2</sub>SO<sub>4</sub> made fractography extremely difficult. Upon failure, a glassy phase, molten Na<sub>2</sub>SO<sub>4</sub> and/or corrosion product, flowed over the fracture surface obscuring the failure marks (see Figure 10). A mild HF solution was used to remove this glassy phase, but, in doing so, it also removed the glassy phase inherent to the material that highlights the details on the fracture surface.

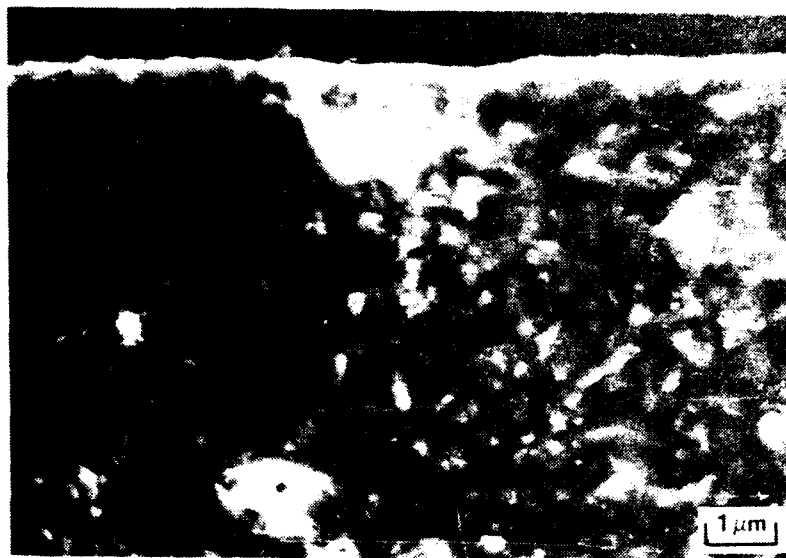
Figure 11. Corrosion pit ( $\approx 10$  to  $15 \mu\text{m}$ ) which is formed when sodium sulfate is added to the stress rupture tests.

The slope of the profile in Region II changes significantly due to a change in the strength-limiting defect. Fractographic analysis shows that corrosion pits  $\approx 10$  to  $15\ \mu\text{m}$  in size are being formed (see Figure 11). It is the formation of these pits rather than slow crack growth that reduces the time-to-failure in Region II.

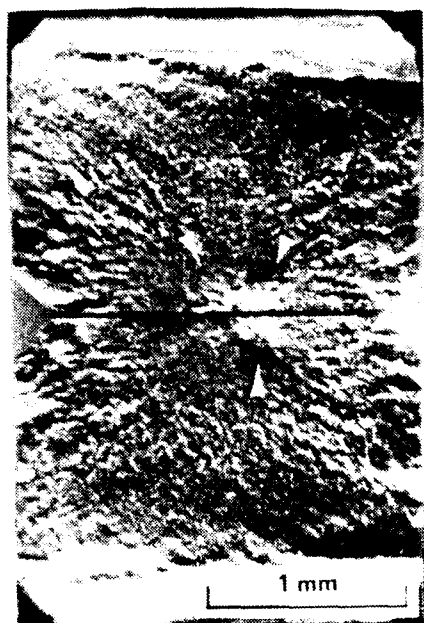
Figure 12a. Optical photograph of the fracture surface of an as-received NC-132 specimen which was used to determine the retained strength after surviving 500+ hours at 1000°C under a 400 MPa stress. SCG region is outlined.

The retained strength of the  $\text{Si}_3\text{N}_4$  did change, not only with the addition of the  $\text{Na}_2\text{SO}_4$ , but also with an increase in applied stress. The change after the addition of  $\text{Na}_2\text{SO}_4$  is due to the formation of corrosion pits as previously seen in this study (see Figure 11) and in Reference 13. The change with applied stress is due to slow crack growth. Figures 12a and 12b are the fracture surface of the as-received specimen that were subjected to 400 MPa and 300 MPa stress, respectively. In Figure 12a, a SCG zone is evident but none is evident in Figure 12b. This SCG zone increases the flaw size thus decreasing the retained strength. If the SR tests were to run for 1000 hours instead of 500 hours, the specimens subjected to the 400 MPa stress may have failed, and, in those subjected to a 300 MPa stress, a visible SCG zone may have started to form. No SCG was observed on the retained strength fracture surfaces of the  $\text{Si}_3\text{N}_4$  after SR with the sodium sulfate present.
